# REMOTE INSPECTION OF A HIGH LEVEL RADIOACTIVE WASTE STORAGE TANK FOR CRACKING, THINNING, AND PITTING

WSRC-MS-2003-00477

J.B. Elder, B.J. Wiersma, and R.L. Sindelar  
Savannah River Technology Center  
Materials Technology Section  
Aiken, South Carolina 29808

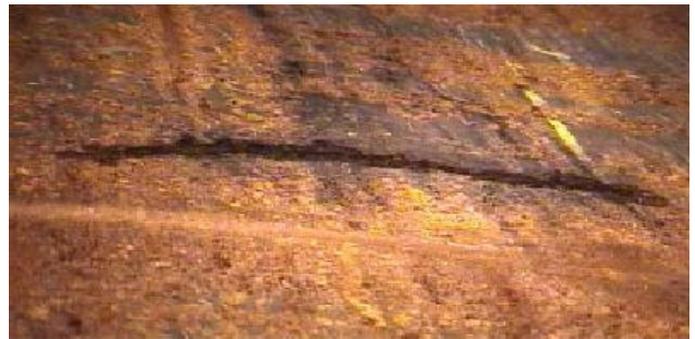
Figure 5: Example of Through-Wall Bleed-Out

Through-wall bleed-out is the term being used to describe the field implemented variation of a liquid penetrant surface inspection technique. It was noted that the water being used for UT couplant, would penetrate (through capillary action) surface cracks. Due to the elevated temperature of the tank wall (~120 degrees F), the wetted surface would dry after a few minutes. Where there was a crack open to the exterior surface, the water drawn into the crack would then bleed out providing a high contrast image of the open crack. Video cameras were utilized to view these indications and make crude measurements of length as the crawler was driven along the indication(s). Figure 5 shows an example of the video image of the bleed-out region.

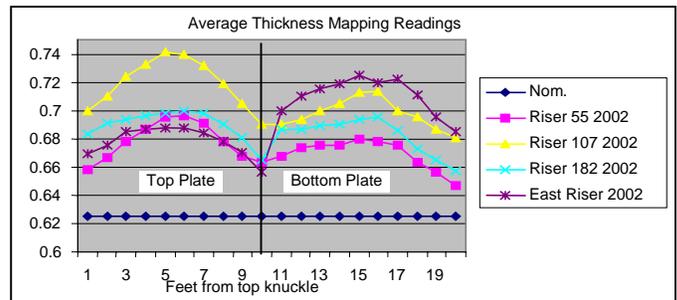
Figure 8 Average Thickness Summary Plot

**Thickness Mapping.** Thickness mapping was performed on 1% of the circumference of the tank for the entire accessible height of the tank (see Figure 8). These thickness mapping examinations were performed to detect and measure any general wall loss, pitting or interface attack in all regions of the tank including the vapor space. No reportable wall loss or pitting was detected.

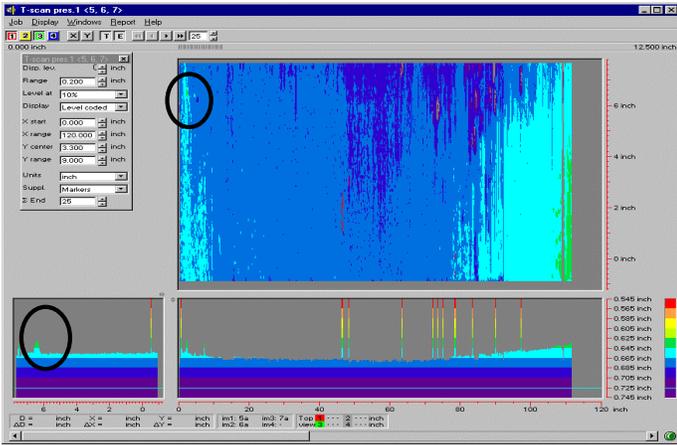
Figure 9 Thickness Mapping Image of Lower Plate, Riser 55

**Vertical Strip.** Inspections the tank through riser IP 55 included one vertical strip for the entire accessible height of the tank. No reportable areas were detected in the vertical strip. The minimum thickness detected in the upper and lower plates are above nominal thickness. The minimum thickness detected in the upper plate was 0.639 inch and is near the edge of the plate toward the middle weld. The minimum thickness detected in the lower plate was 0.632 inch. This minimum thickness area is a 0.25 x 0.40 x 0.030 inch deep indication approximately 2.5 inches from the middle weld. The minimum thickness at the bottom of the same plate is 0.634 inch. The indication, inside the black circles on Figure 9, was approximately 0.030 inch deep. The results also show the plates to be thinner at the edges. There are several noise spikes shown in the side and end views. These noise indications were evaluated and determined to be non-relevant. No Crack-like indications were detected in this strip.

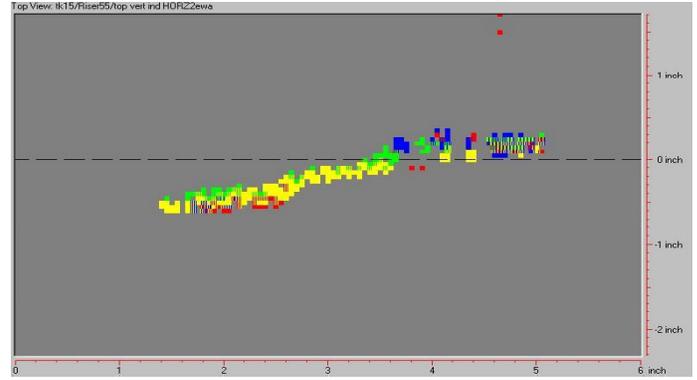
Figure 10 P-scan Data of Crack in Upper Plate Vertical Weld, Riser 55

**Previous Indication Investigation.** One previously identified indication in the upper plate vertical weld at approximately 53 feet was also examined under riser IP55. The indication was observed at 200 inches above the tank bottom. Due to the high weld profile and limited time and the fact that the examination of this leak site was not a requirement of the inspection scope, the indication was only examined from one side of the vertical weld. The examinations were performed on the side of the weld opposite the riser. The crack was confirmed to be through wall, but also had a partial through wall segment. Measuring the indication on the right side only, the through wall portion was 1.4 inches. The total length was 3.7 inches on that side of the weld. Figure 10 shows some of the UT data from this indication.

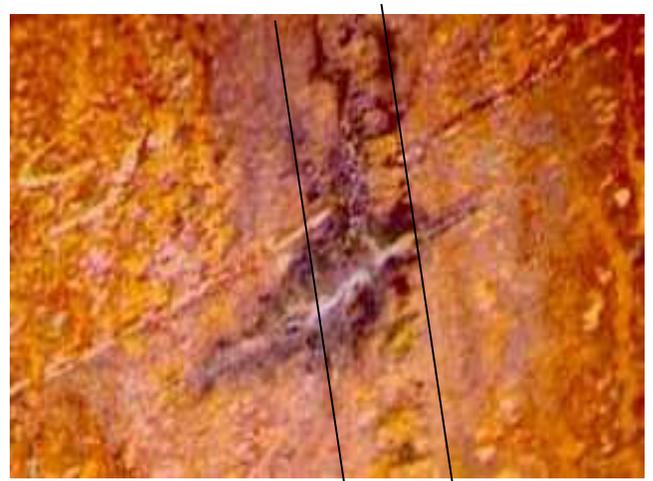
Figure 11 Visual Image of Crack in Upper Plate Vertical Weld, Riser 55

A picture of the indication, rotated to the same orientation as the P-scan data is shown in Figure 11. The image is rotated 180 degrees (up-side down). The vertical weld edges are marked on the image. Only the part of the indication on the left side of the picture was scanned (Right side of weld looking at tank). The through wall portion of that crack which is visible in the picture is represented by the blue portion of the P-scan data in Figure 10. The yellow and green portions of the P-scan image indicate the part of the crack that is only partially through wall.

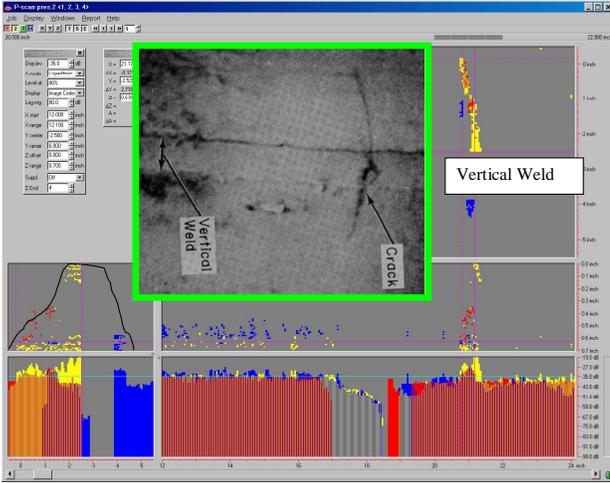
Figure 12 Image of Perpendicular Crack With Liquid Penetrant Results Overlay

**Vertical Weld.** The following is a summary of the indications detected in the lower plate vertical weld. The through wall indication (see Figure 12) measured 4.5 inches total length. The photograph overlay is from a liquid penetrant inspection performed on a similar tank in 1962. The recently detected crack is nearly identical to the crack from 1962.

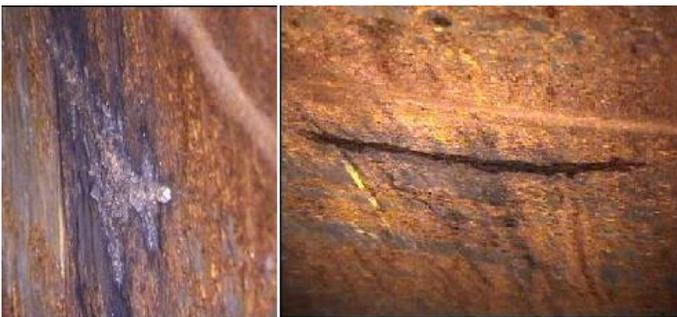
Figure 13 As-Found and Bleed-out Image of Crack at 192 feet, Middle Horizontal Weld

**Leak Site at 192 feet, Middle Horizontal Weld.** The leak site at 192 feet is a horizontal/arched crack in lower plate at a weld repair location (see Figure 13). The through-wall portion (verified visually with bleed-out technique) of this crack was measured ultrasonically to be 10.2 inches. The indication is arch shaped around a weld repair region in the horizontal weld. The weld repair area appears to be approximately 8 inches long and centered on the through-wall portion of the crack. The total length of the indication was measured at 18.1 inches. As shown in Figure 14, this indication is longer at the inside surface than on the outside.

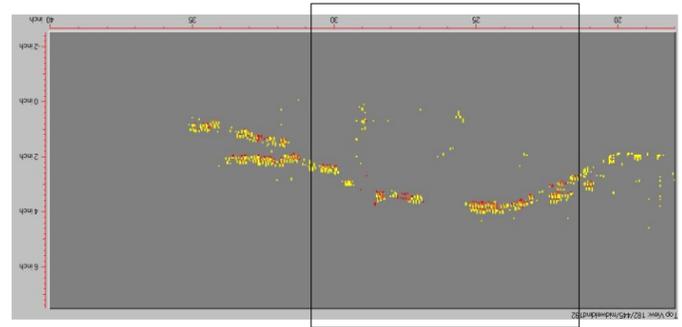
Figure 14 P-scan Image of Crack at 192 feet, Middle Horizontal Weld. The through wall part of crack shown in boxed area. The P-scan image has been rotated to same orientation as the visual image in Figure 14.
